Manhole Inspection Summary

Manhole # S21A__012MH

Insp Date: **10/22/07 9:30 AM**

Location Address: **1900 LANVALE-HARLEM**

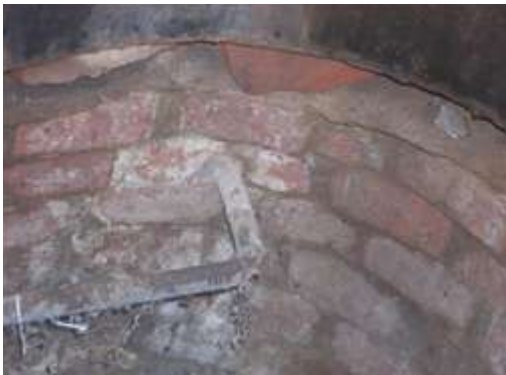
Defect 2

Condition: ☐ Sound ☐ Cracked ☐ Root Intrusion ☐ Loose Brick ☒ **Deteriorated**

CORBEL DETERIORATION

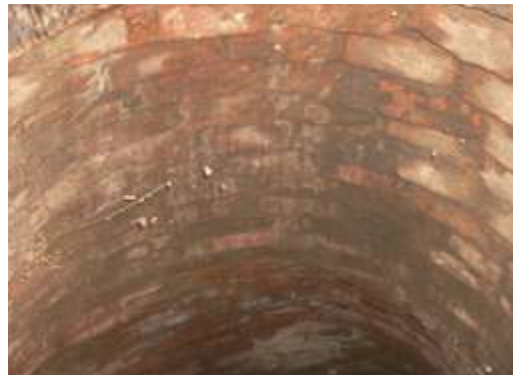
Defect 1

Infiltration: ☐ None ☐ Joint ☐ Cracks ☐ Mortar ☐ Roots ☒ **Wall**

CORBEL INFILTRATION

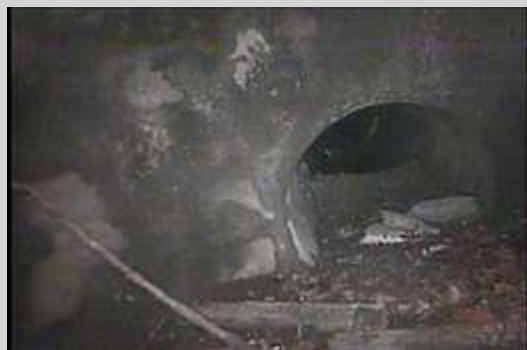
12 O'Clock Outflow

8 in. Circular Gravity Sewer
Pipe Out @ 12 O'Clock

Deposits: ☐ None ☒ **Mud** ☐ Sludge ☒ **Debris** ☐ Grease

Silt Depth: **2** (in.) Deposits Extent: **Light**
